Federal Democratic Republic of Ethiopia
Ministry of Transport
Aircraft Accident Investigation Bureau

Aircraft Accident Investigation Preliminary Report
Ethiopian Airlines Group
B737-8 (MAX) Registered ET-AVJ
28 NM South East of Addis Ababa, Bole International Airport
March 10, 2019

Report No. AI-01/19

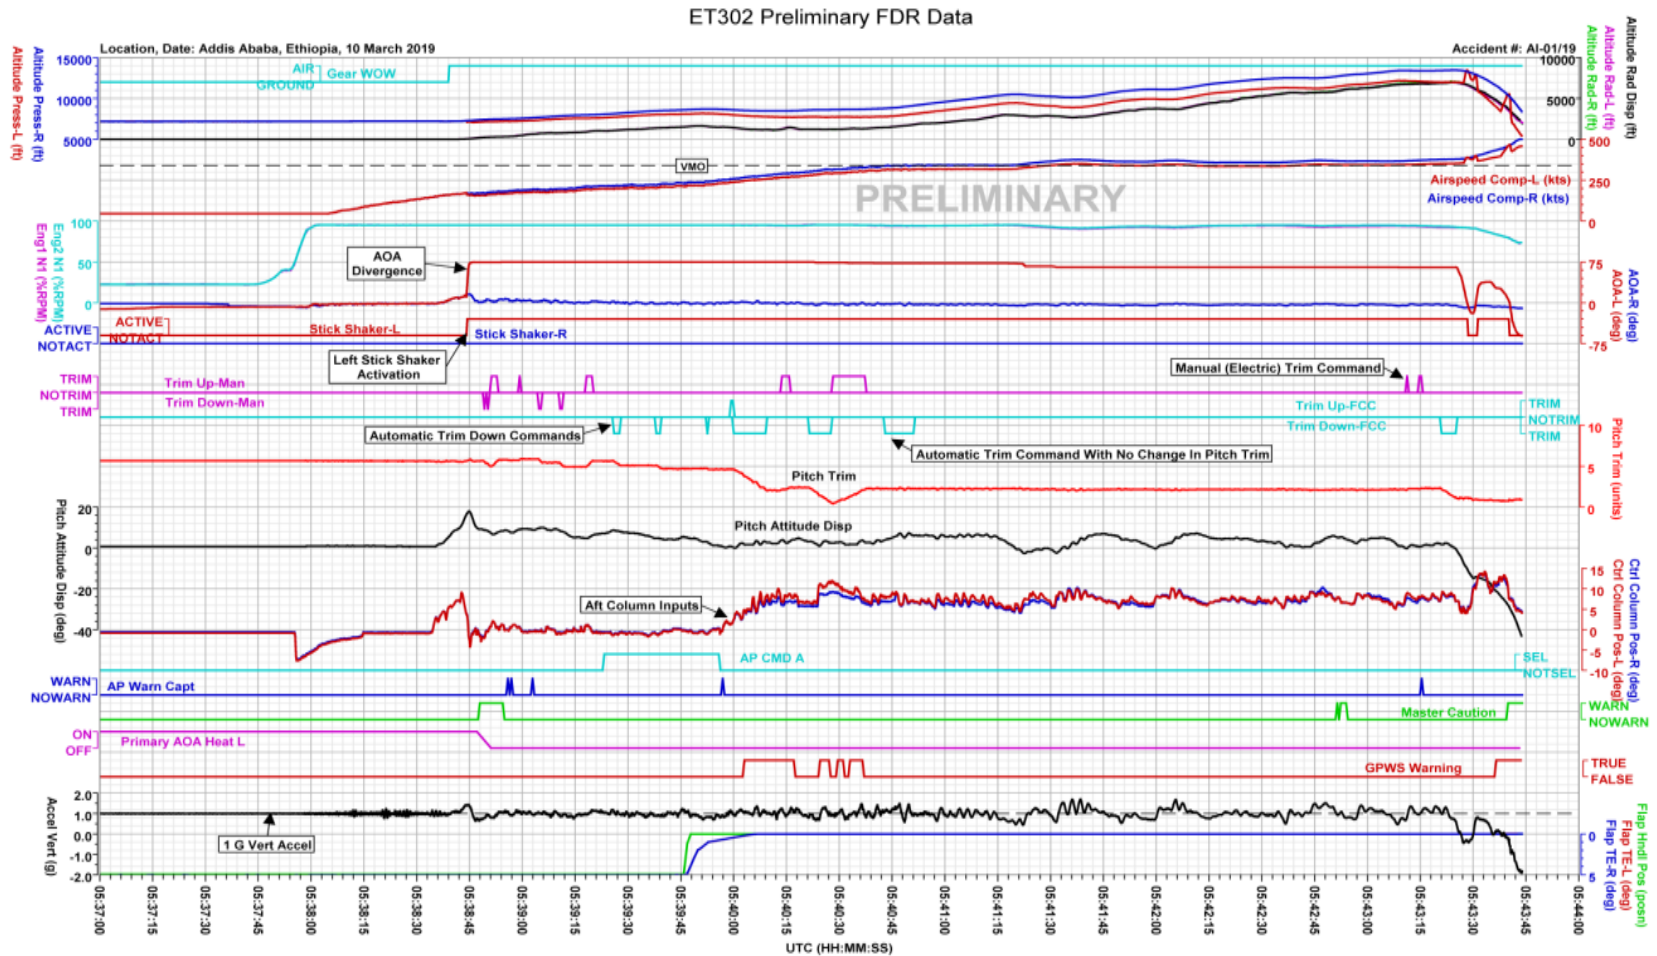
APPENDIX 1

General Overview of Flight
