# Aviation Investigation Preliminary Report

| <b>Location:</b> | Louisville, KY | <b>Accident Number:</b> | DCA26MA024 |
| <b>Date &amp; Time:</b> | November 4, 2025, 17:14 Local | <b>Registration:</b> | N259UP |
| <b>Aircraft:</b> | McDonnell Douglas MD-11F | <b>Injuries:</b> | 14 Fatal, 2 Serious, 21 Minor |

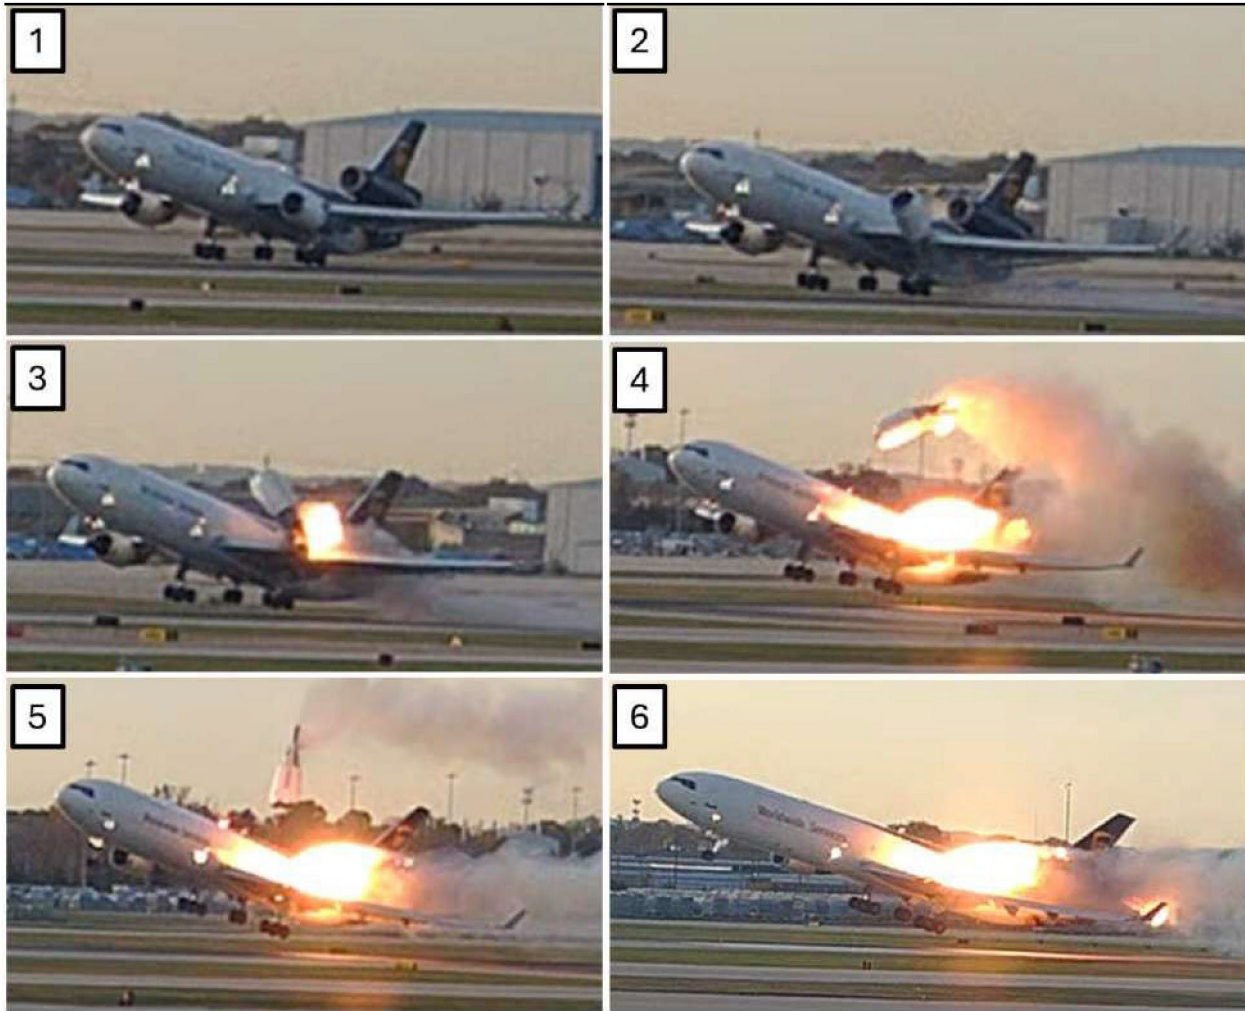
airplane rotated for takeoff. Airport surveillance video of the airplane showed the left (No. 1) engine and pylon separating from the wing shortly after airplane rotation, with a fire igniting on the left engine while it traversed above the fuselage and subsequently impacted the ground (see figure 1). A fire ignited near the area of the left pylon attachment to the wing, which continued until ground impact.

**Figure 1.** Still images from an airport surveillance video showing the left engine and left pylon separation from the left wing. (Source: UPS)

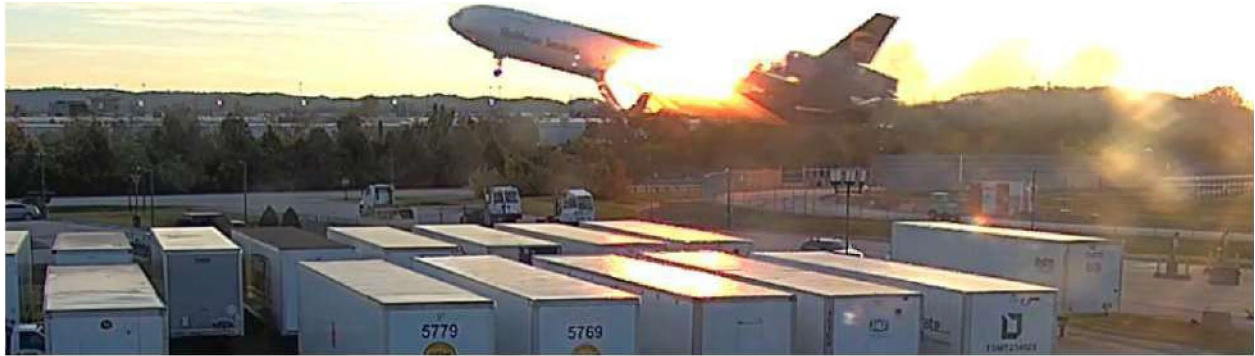
**Figure 2.** The fire in the area of the left pylon attachment to the wing continued as the airplane cleared the blast fence.

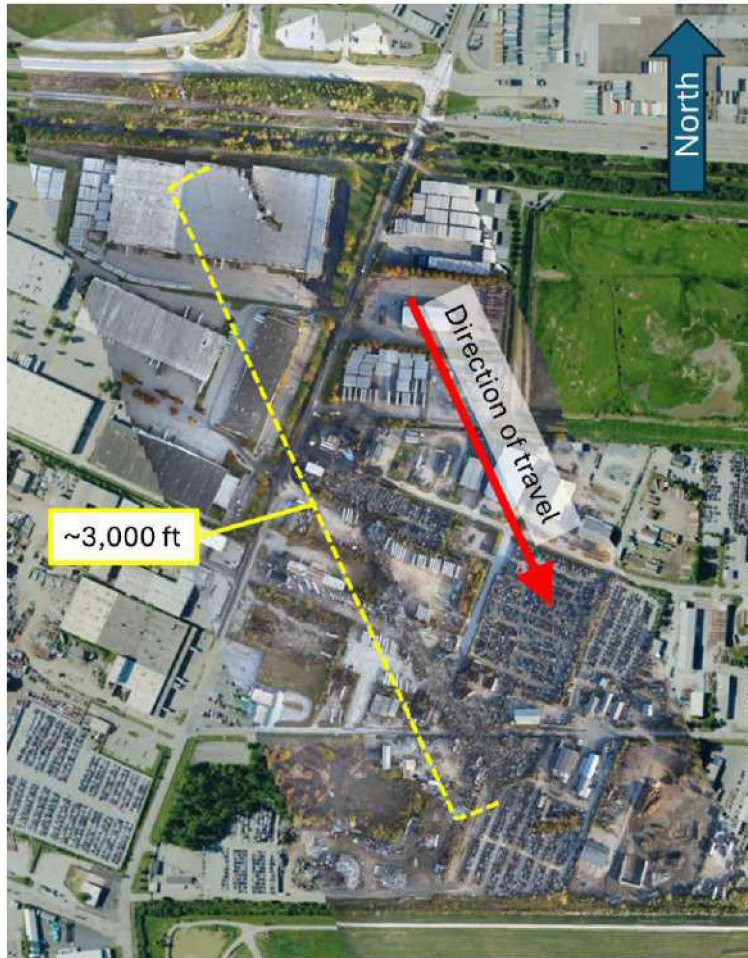
The airplane initially climbed but did not get higher than about 30 ft above ground level (agl) according to radio altitude data from the FDR. (Based on FAA-provided ADS-B data, the last data point showed 481 ft mean sea level [msl] and 100 ft agl.) The airplane cleared the blast fence beyond the end of runway 17R, but the left main landing gear impacted the roof of a UPS Supply Chain Solutions warehouse at the southern edge of the airport (see figures 2 and 3). The airplane then impacted a storage yard and two additional buildings, including a petroleum recycling facility, and was mostly consumed by fire. The wreckage area continued from the

UPS warehouse to about 3,000 ft south-southeast of it (see figure 4). The accident site debris was centered about 38° 8' 49.85" north by 85° 44' 3.86" west.

**Figure 4.** Accident site composite view created from aerial imaging overlaid on a Google Earth image. The upper end of the yellow-dashed bracket is the initial impact between the airplane landing gear and the UPS building roof.A

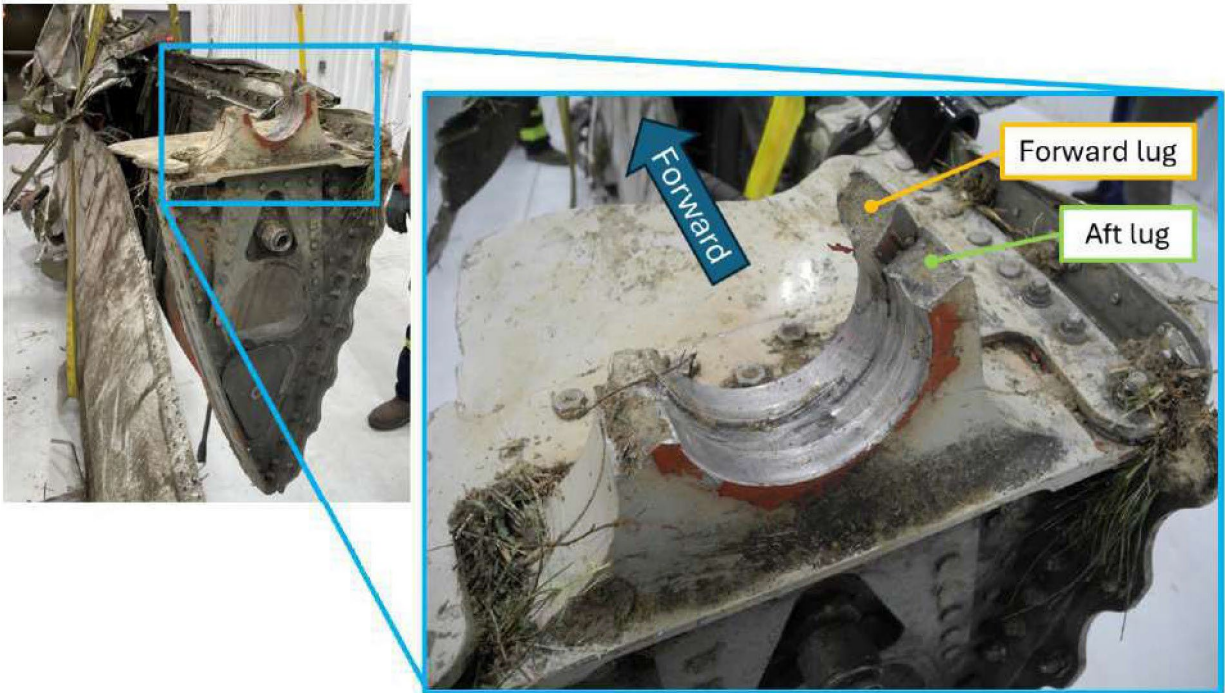
The left pylon aft mount's forward and aft lugs were both found fractured near their 2 o'clock (inboard fracture) and 9 o'clock (outboard fracture) positions when in the aft-looking-forward frame of reference (see figure 7). The fractured and separated upper portions of the forward and aft lugs were found adjacent to runway 17R. The left wing clevis, aft mount spherical bearing, and aft mount attachment hardware were found with a portion of the left wing at the accident site. The bolt, spherical bearing, and associated hardware remained attached to the wing clevis. The spherical bearing outer race had fractured circumferentially, exposing the ball element (see figure 8).

**Figure 7.** The separated left pylon after recovery (left image) and the left pylon aft mount's fractured forward and aft lugs (right/enlarged image).

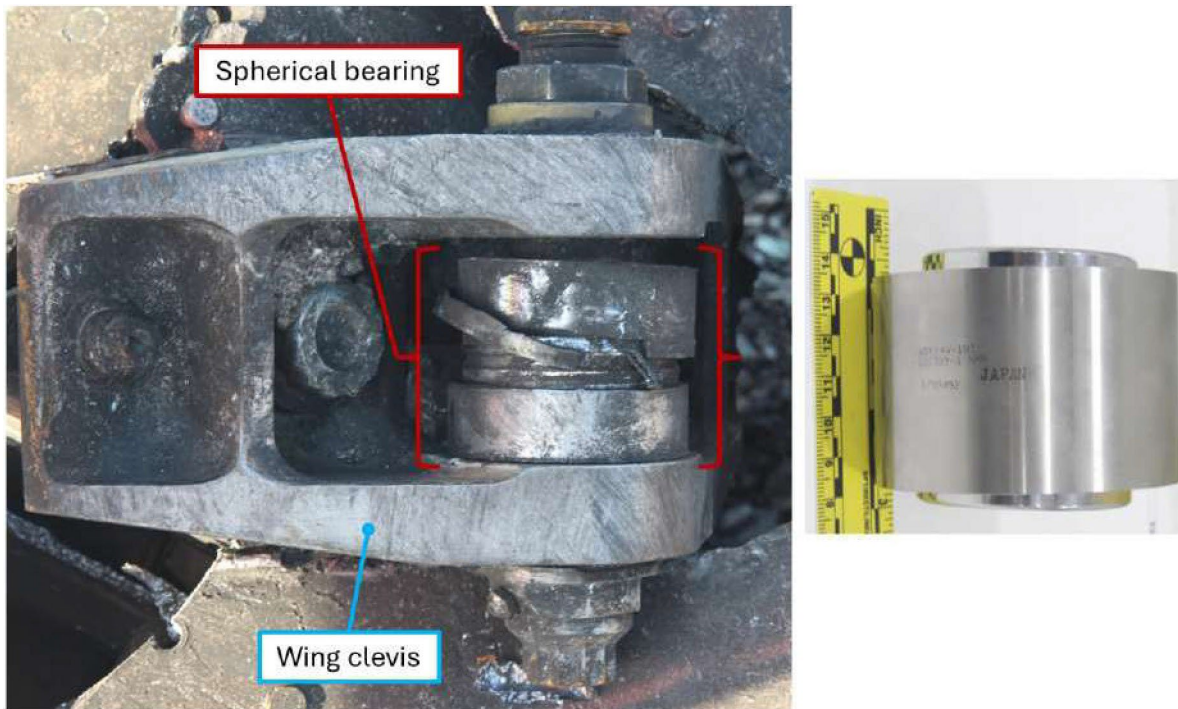
**Figure 8.** The left wing clevis, fractured spherical bearing (marked by the red brackets), and associated attachment hardware found at the accident site (left) and an exemplar spherical bearing (right).

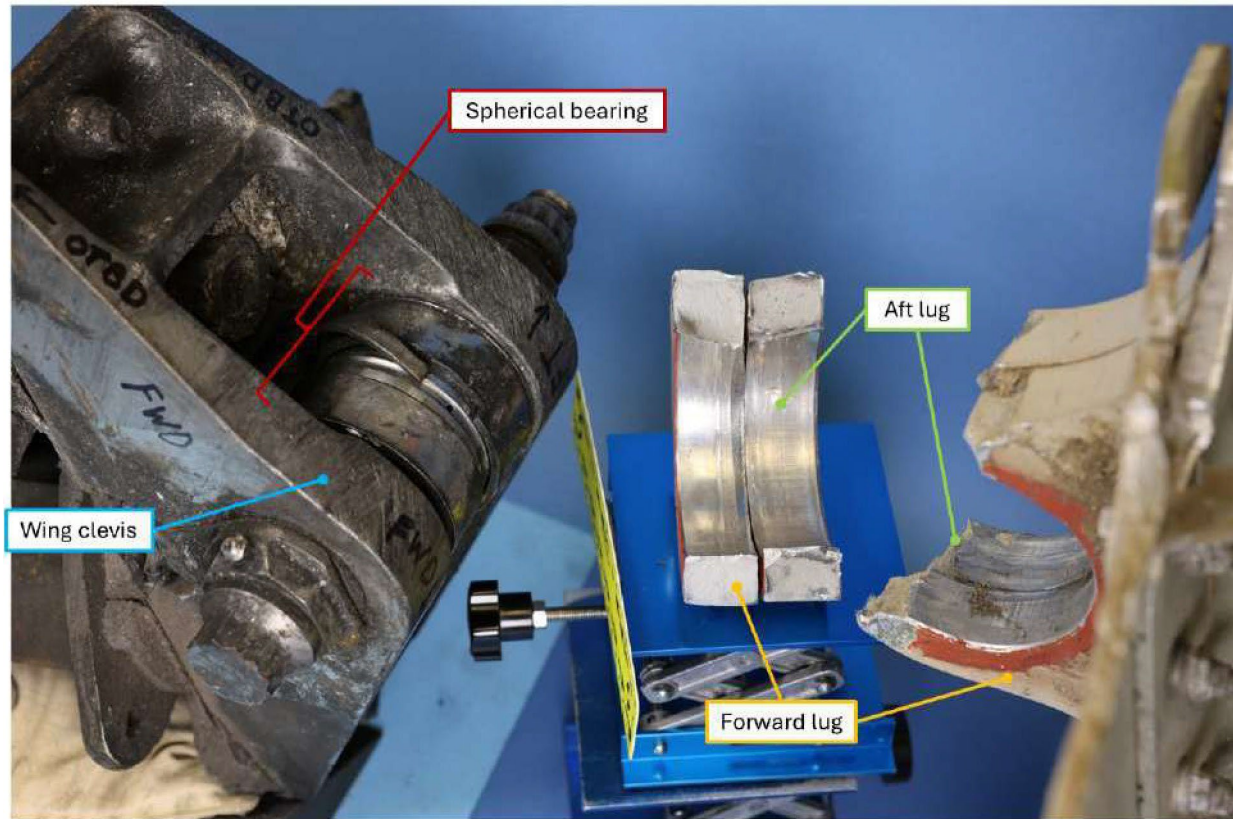
The left pylon aft mount, fractured lugs from the left pylon aft mount, and the left wing clevis (containing the aft mount spherical bearing and attachment hardware) were retained for further examination at the NTSB Materials Laboratory (see figure 9). The right pylon aft mount and wing clevis assembly as well as two engine fan blade fragments found on runway 17R were also retained for further examination at the NTSB Materials Laboratory.

**Figure 9.** The left pylon aft mount, the fractured and separated forward and aft lugs, and the left wing clevis containing the attachment hardware and fractured spherical bearing.

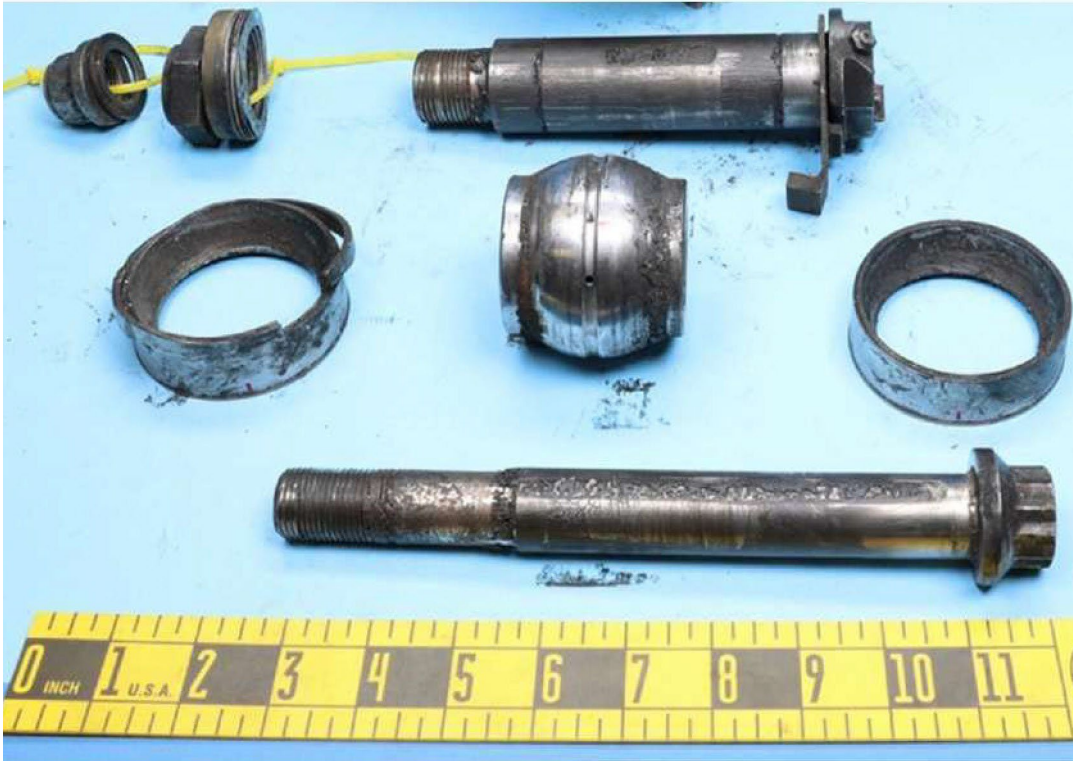
After initial cleaning of the fracture surfaces, examination of the left pylon aft mount lug fractures found evidence of fatigue cracks in addition to areas of overstress failure. On the aft lug, on both the inboard and outboard fracture surfaces, a fatigue crack was observed where the aft lug bore met the aft lug forward face. For the forward lug's inboard fracture surface, fatigue cracks were observed along the lug bore. For the forward lug's outboard fracture surface, the fracture consisted entirely of overstress with no indications of fatigue cracking. The forward top flange of the aft mount assembly was examined for indications of deformation or pre-existing fractures, but no indications were found. The spherical bearing was removed from the wing clevis for further evaluation (see figure 10).

**Figure 10.** The spherical bearing and attachment hardware after removal from the left wing clevis.
