# Aviation Investigation Preliminary Report

| <b>Location:</b> | Louisville, KY | <b>Accident Number:</b> | DCA26MA024 |
| <b>Date &amp; Time:</b> | November 4, 2025, 17:14 Local | <b>Registration:</b> | N259UP |
| <b>Aircraft:</b> | McDonnell Douglas MD-11F | <b>Injuries:</b> | 14 Fatal, 2 Serious, 21 Minor |

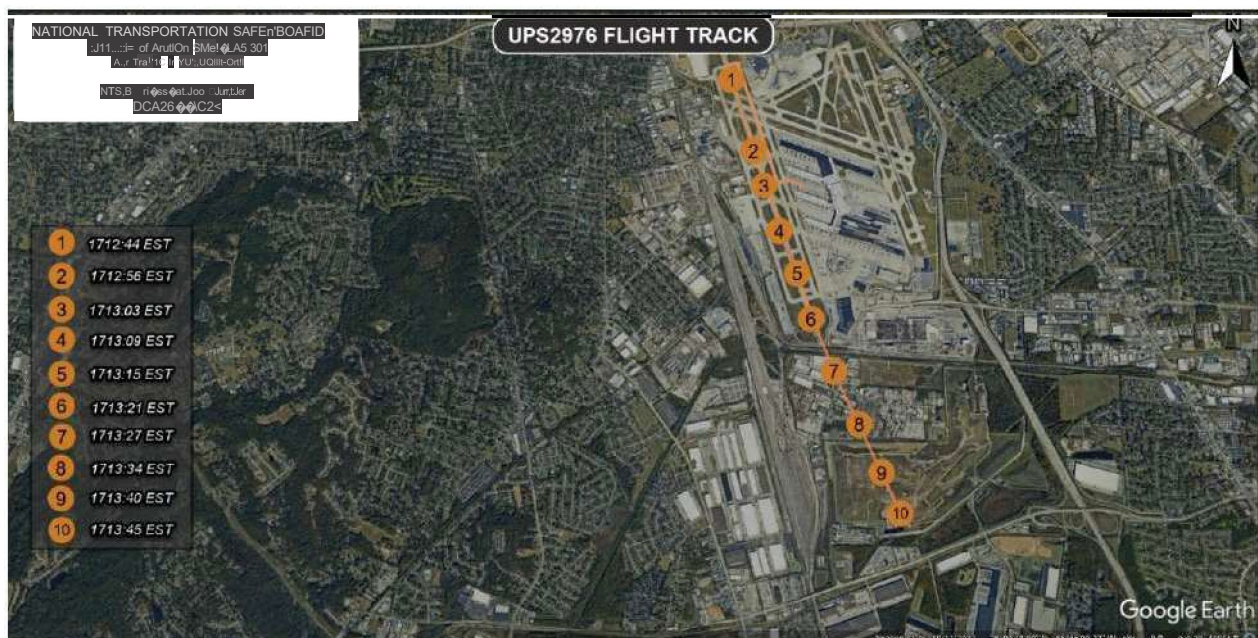
**Figure 3.** Graphic depicting the flight track of UPS flight 2976 based on ADS-8 data.

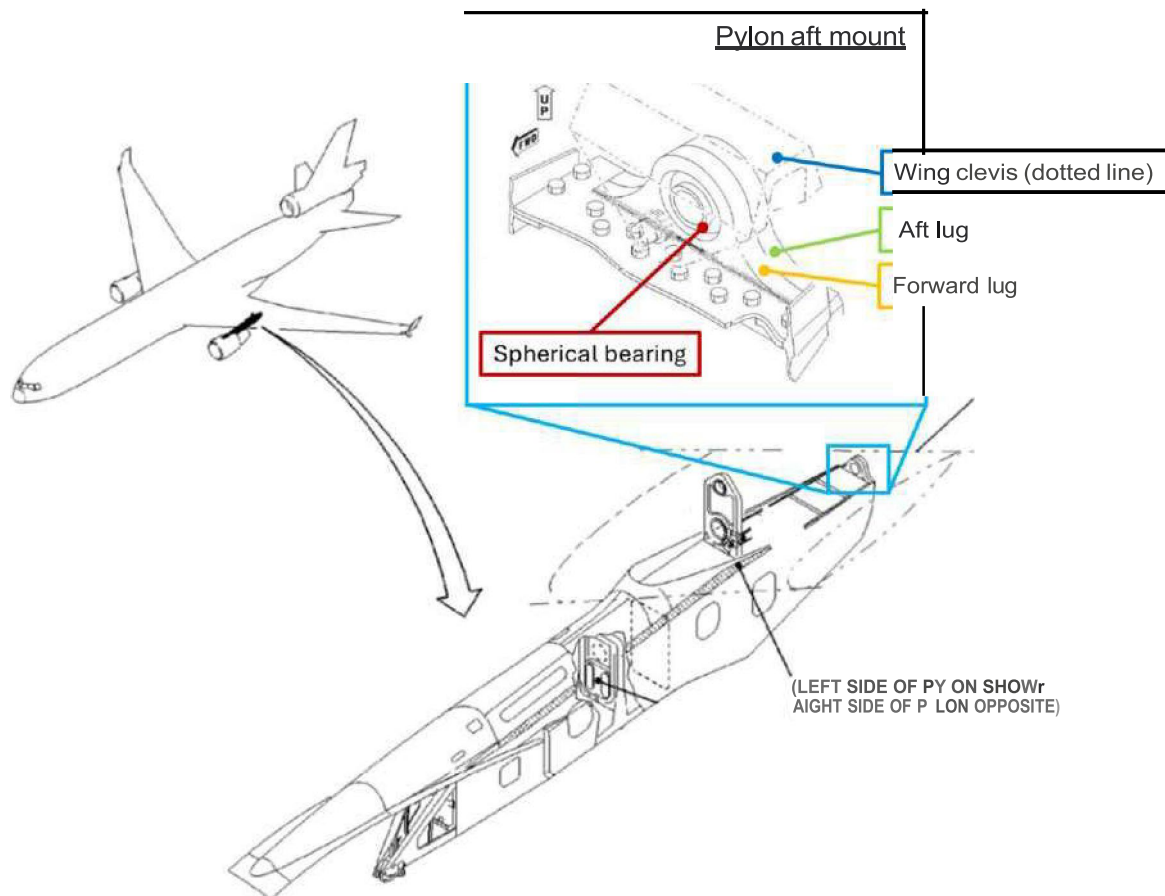
The thrust link assembly, located immediately behind the forward mount's lower spherical bearing, primarily transmits thrust loads. The pylon aft mount is an assembly composed of two independent fittings bolted together, with lugs (forward lug and aft lug) that house a single spherical bearing (see figures 5 and 6). For this report, references to the pylon aft mount spherical bearing includes both the bearing's ball element (sphere) and its outer race. A clevis

on the underside of each wing ("wing clevis") connects to the pylon aft mount via attachment hardware.

**Figure 5.** The pylon-to-wing mount diagram, with the inset image showing details of the pylon aft mount connection to the wing clevis. (Source: Boeing, edited by NTSB)

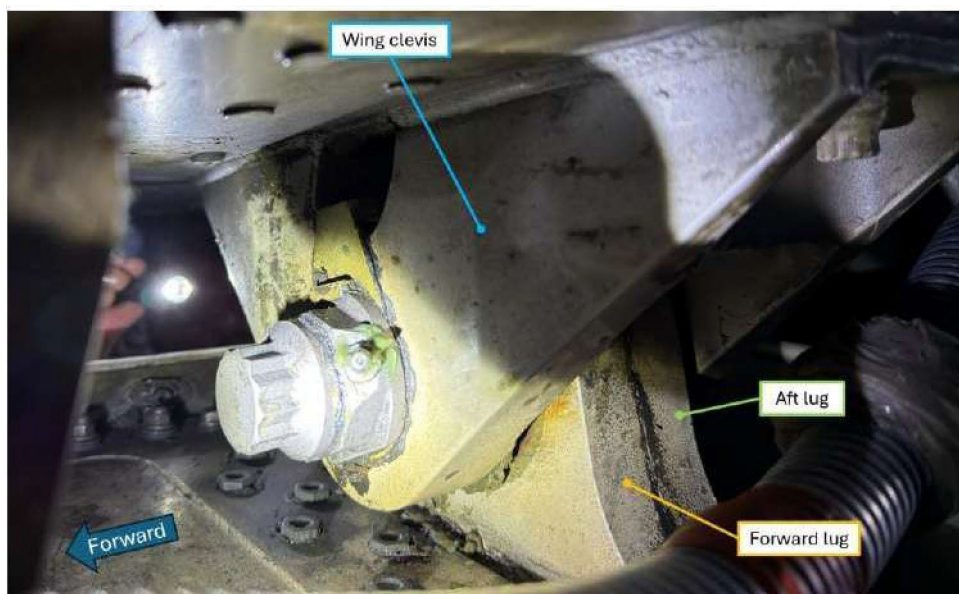
**Figure 6.** An exemplar installation of the pylon aft mount to the wing clevis. The aft mount spherical bearing is obscured by the wing clevis.
